Architectural Heritage Impact Assessment

Property Address; Kilmacthomas Greenway Railway Station
Kilmacthomas Co Waterford.

Date; 29 February 2024

Report Author; Tom Finnegan MRIAI, Finnegan Architects

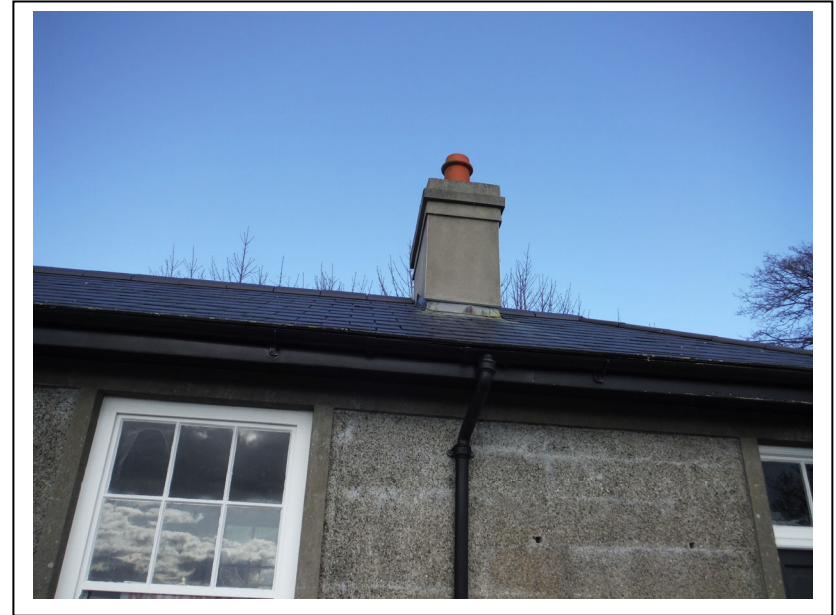
What appears to be cementitious new render has been applied to the two chimneys with new chimney pots and flashing.

Fig 6 Chimney Stack

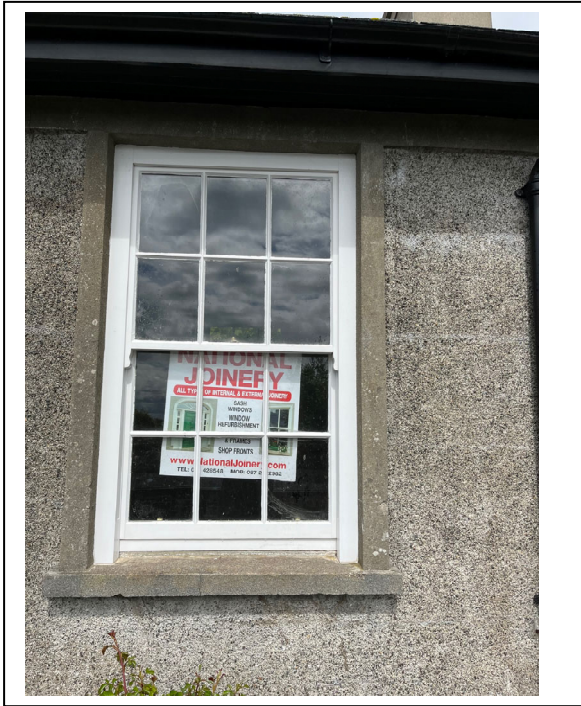
New windows were installed in 2017 six over six timber single glazed sash windows.

Fig 7 New Timber Sash Windows

No change is being proposed to the current windows and doors which will be incorporated into the new design.

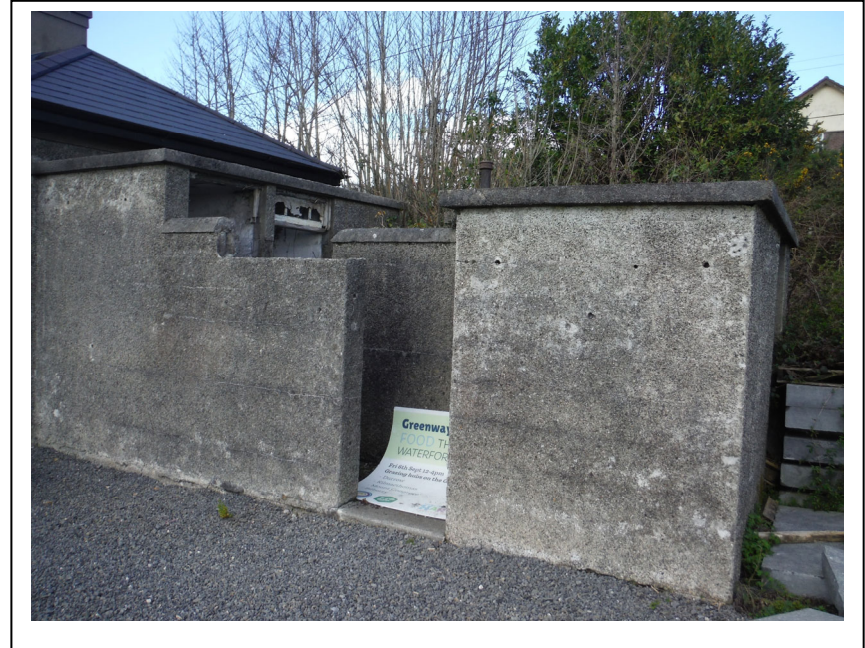
The original Gents toilets are to be maintained in their existing state.

Fig 8 External Gents Toilet

Consideration should be given to repurposing the Gents Toilets as a storage area for the new units and there is a danger that they will fall back into disrepair if they are to be maintained in their present state without practical use.

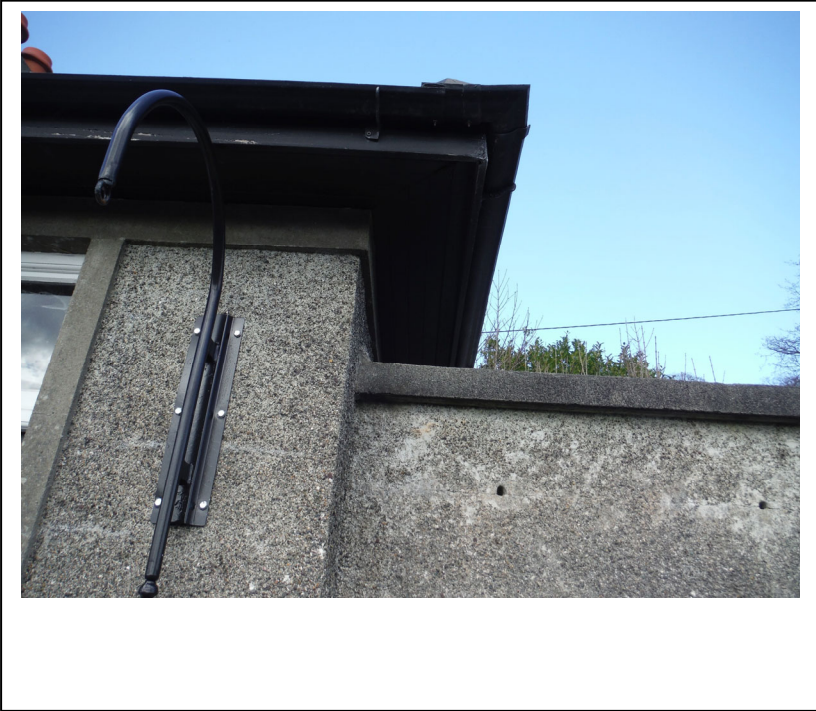
Fig 9 New renovation Eaves with Timber fascia soffit and new metal Gutter

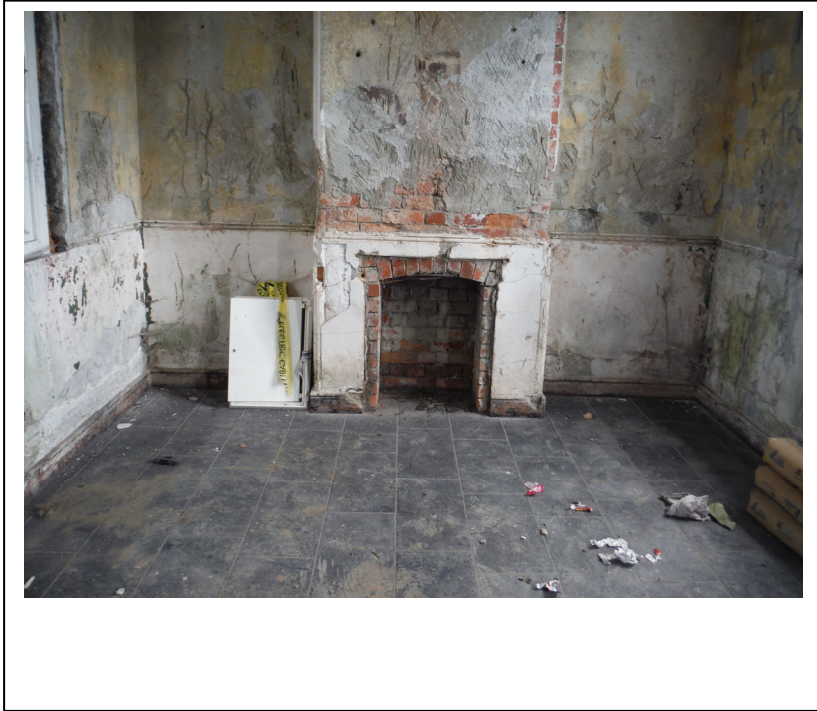
Fig 11 Fireplace with walls on either side to be removed

No changes are being proposed to the outside face as part of the change of use. It is proposed to remove the walls to the side of each of the fireplaces to allow access to new bedrooms at either end of the building. The wall being removed on the west side contains the remains of a safe which is an interesting feature which was recommended to be retained in the 2017 report.

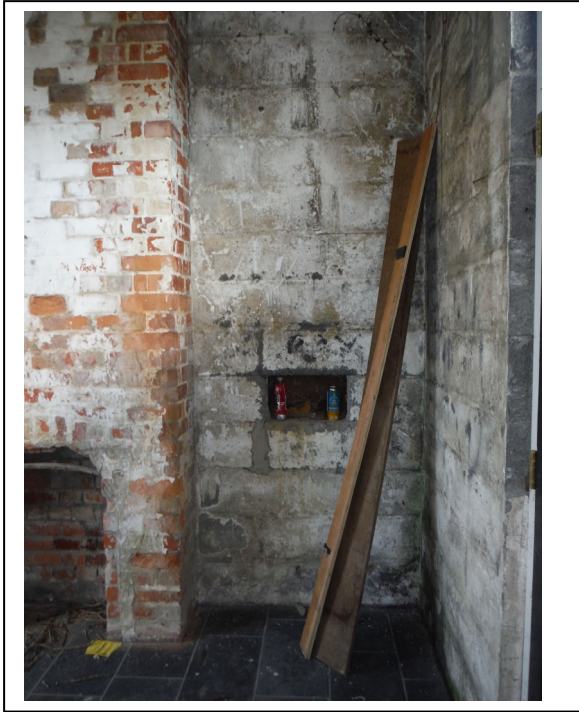
Fig 13 Internal Partition wall beside fireplace to be removed

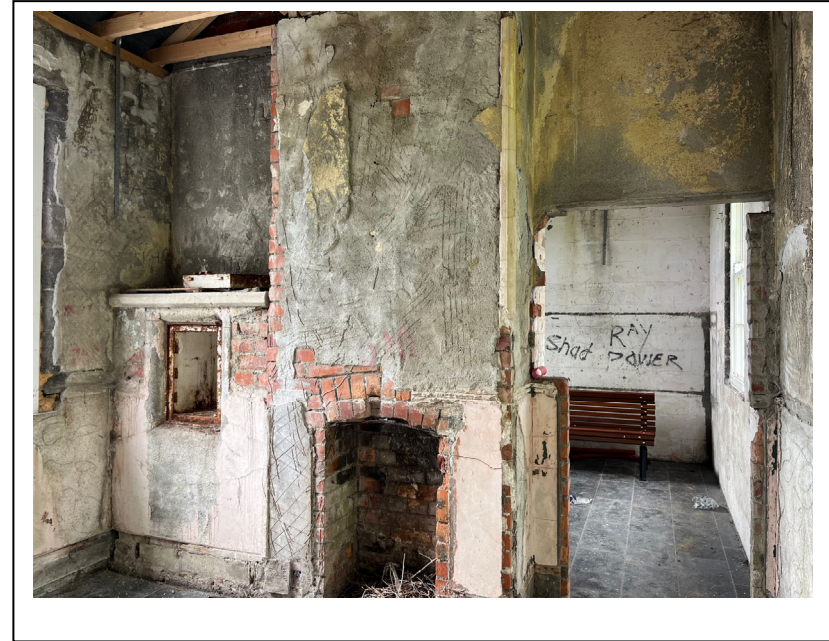
Fig 14 Fireplace with safebox and opening either side.

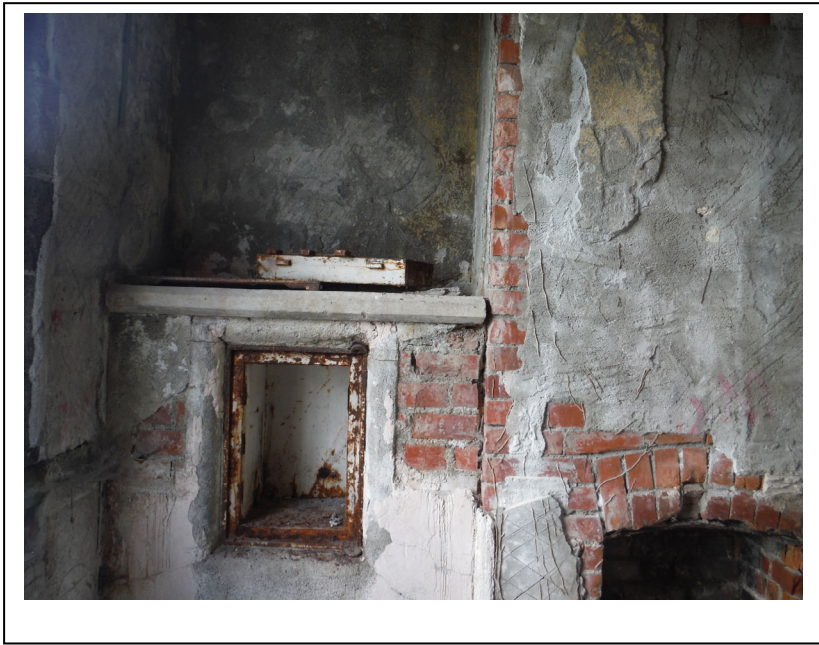
Fig 15 Safebox

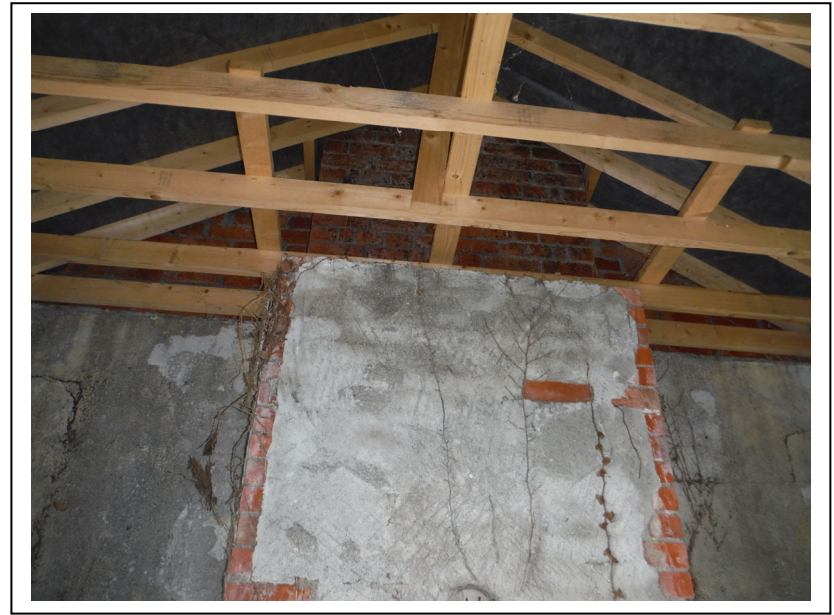
The roof has been fully replaced with new rafters, roof felt, battens, and Fibre cement roof slates.

No insulation has been added between the rafters as originally proposed.

Fig 18 New Roof structure

It is proposed to add rigid insulation between the rafters with insulated plasterboard below with a 50mm vented airspace above.

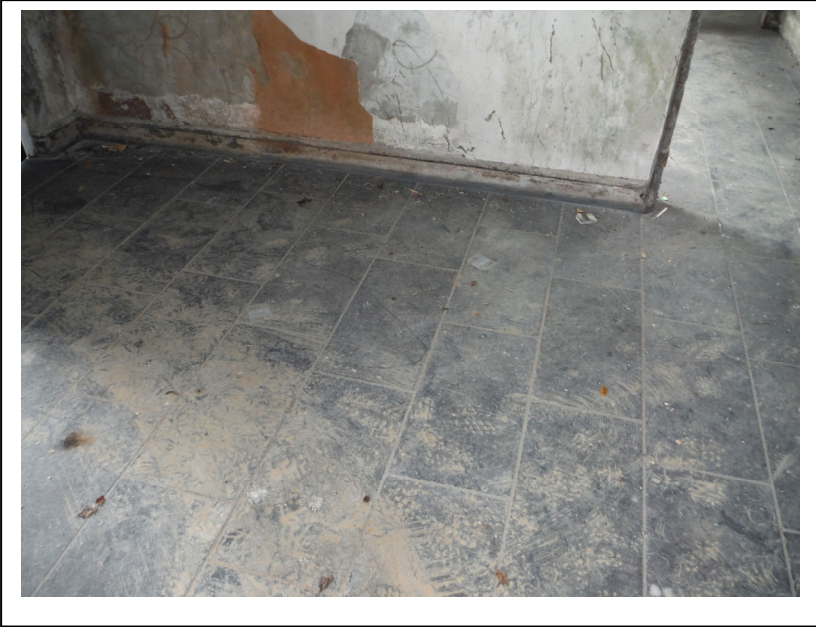
A new limestone flag floor has been installed in the main part of the building. The concrete sub floor remains in the Ladies Toilet on the Southeast end which is accessed from outside separate to the rest of the building.

Fig 19 New Limestone Floor

Retain existing limestone floor and install new limestone floor in southeast bedroom. (Ladies toilet)
