Smith & Henderson

18 Lady Lane, Waterford City.

Plasterwork report.

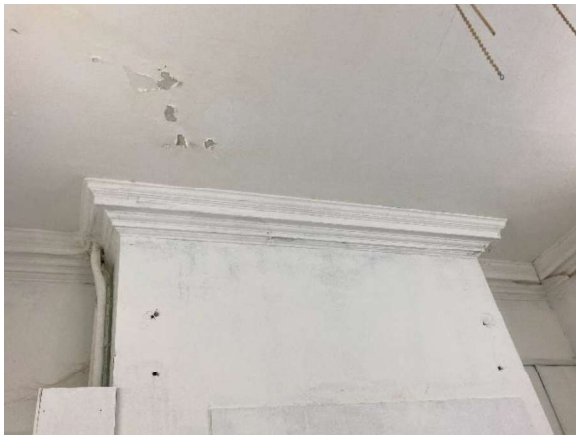
Chimney breast cornice.

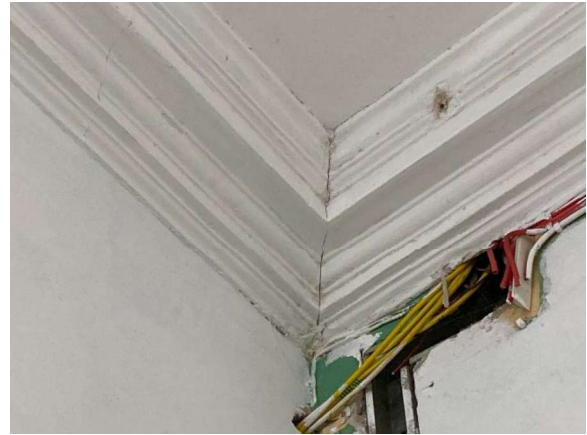
Cornice corner detail.

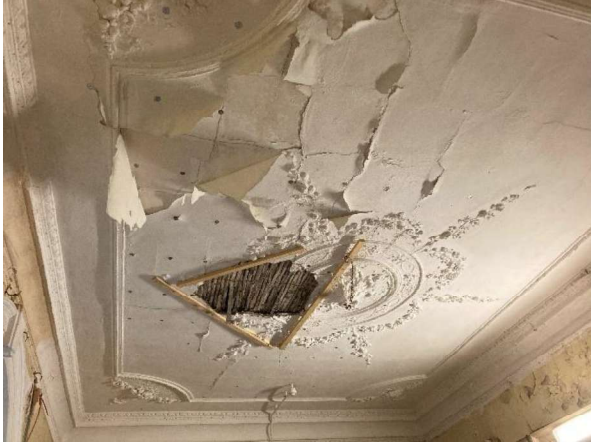
View of ceiling showing restraint works.

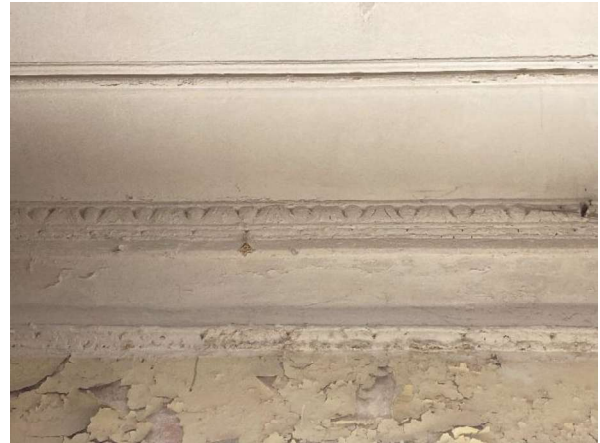
Cornice detail.

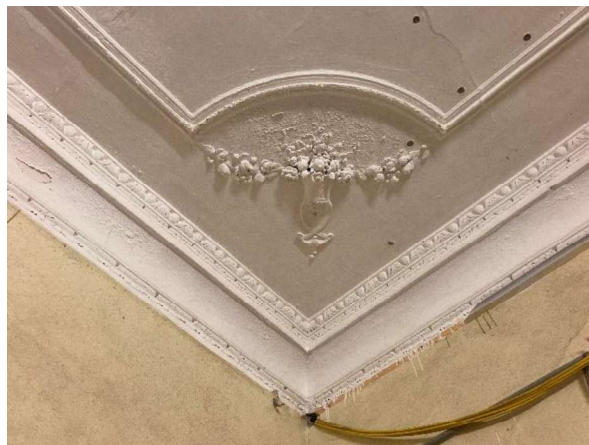
Flower basket enrichment.

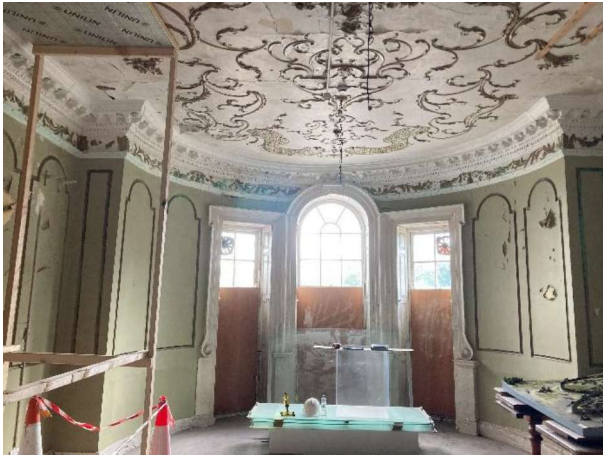
Bow end of room.

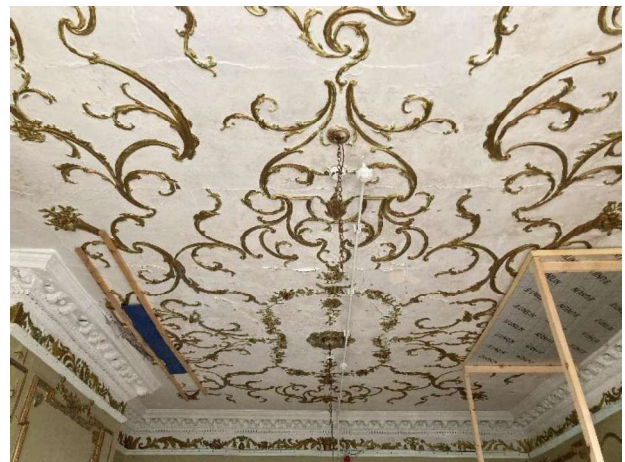
View of rococo ceiling detail.

The removal of the many layers of paint from the decorative plasterwork is something to be considered also. In room G.04 the ground floor drawing room, the ceiling and the frieze in particular, are heavily overpainted and the decorative detail is a shadow of the original intricate design. Sample areas of paint removal would be of great benefit to uncover the quality of the underlying enrichments and also to ascertain the cost/benefit of the proposed restoration works.

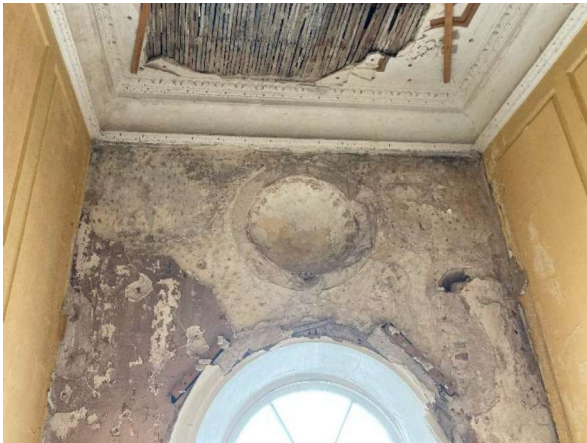
Arched window & filled niches.

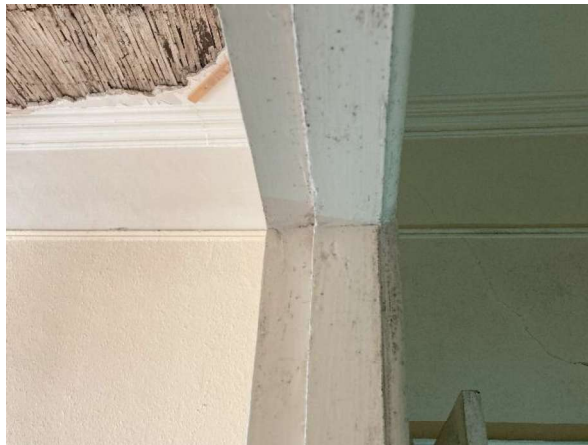
Modern partition breaking through cornice.

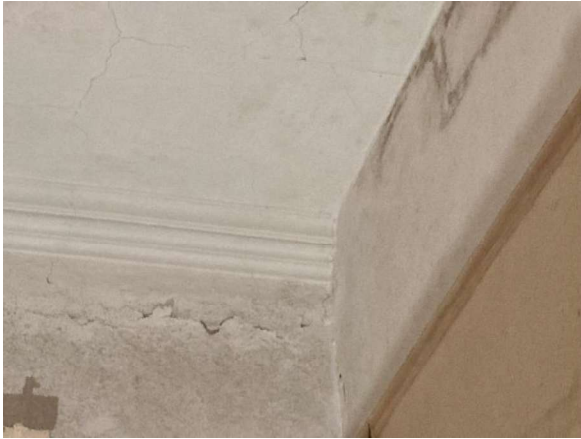
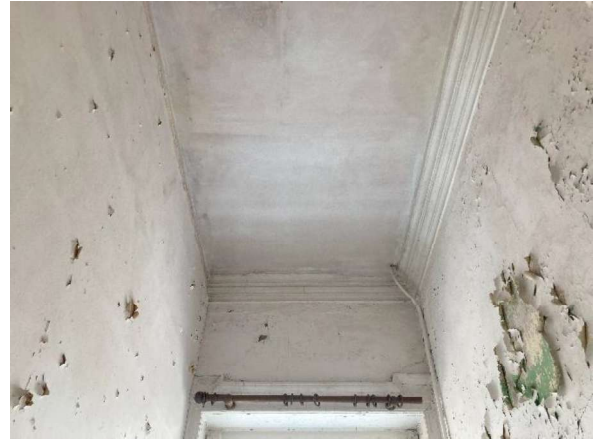
Modern partition built to provide bathroom space.

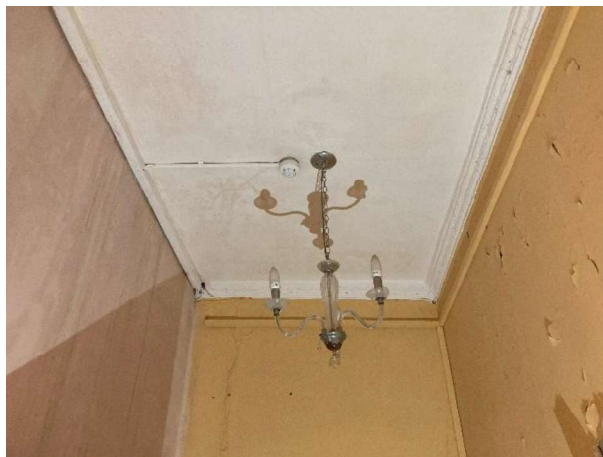
It would appear that there has been some intervention in this area as the south wall between it and the stairwell is of a modern skim coat finish. Also, this wall is missing its small waterleaf pattern cornice which is present on the other three walls.

Landing ceiling with waterleaf detail to cornice.

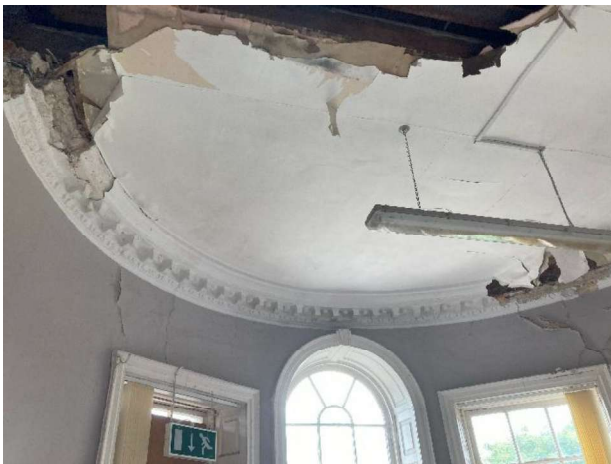
Surviving decorative elements include a cornice with egg-and-dart mouldings, incorporating plain modillions alternating with rosettes. The original ceiling has been replaced with modern plasterboard, now in poor condition. The space has since been subdivided by a modern partition wall.

Bow end of room.

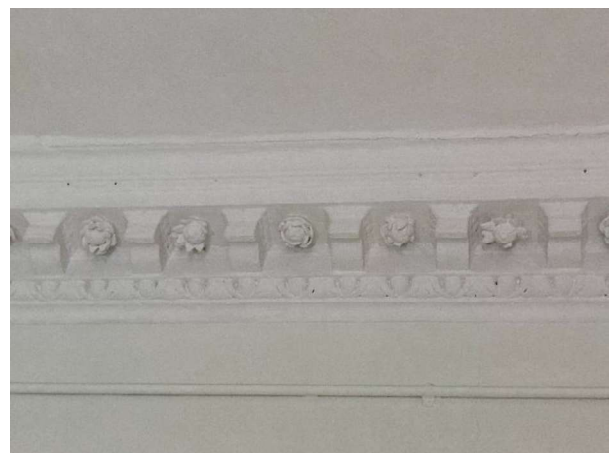
Surviving cornice detail.

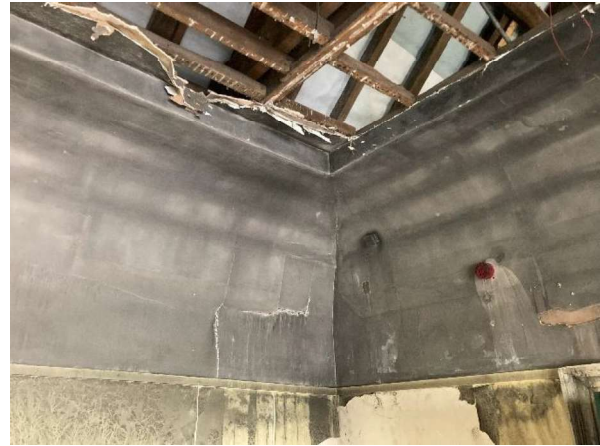
Coved detail, possible modern replacement.

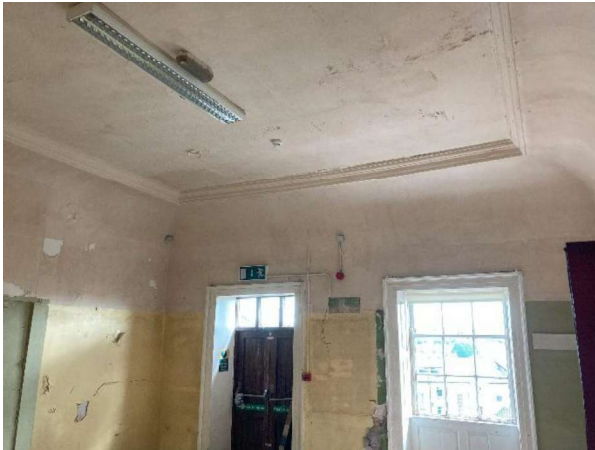
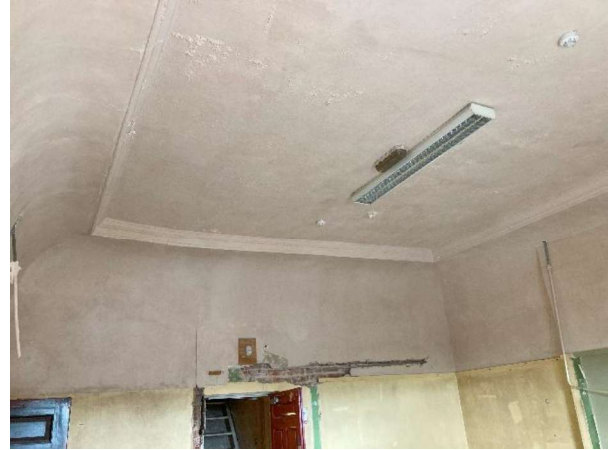
Coved detail similar to Room 2.06 but with extra run mould detail around the compartment.

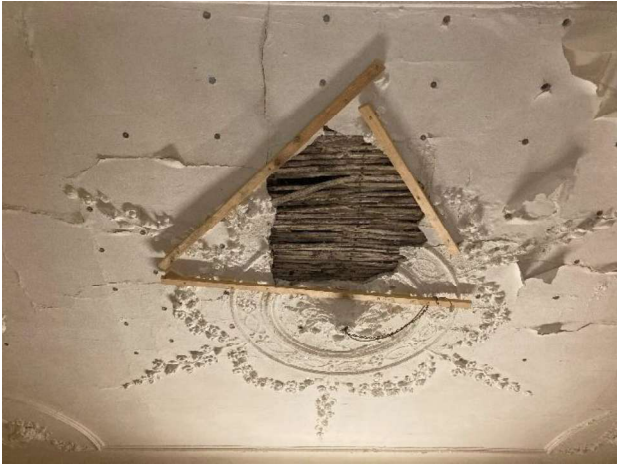
Room G.02

Stabilisation works were carried out in 2016 in Rooms G.02, G.04, G.05, 1.02 & 1.09. The purpose of the works was to install temporary restraints to various areas of ceilings causing concern using stainless steel screws & washers and timber battens screwed into joists.

Currently the priority must be the prevention of any further deterioration of the fabric of the building and in relation to this report, specifically the integrity of the remaining decorative plasterwork. While it is noted that stabilisation works were carried out in 2016, since then there has been further failure of ceiling plaster in Room G.04 which has the most intricate enrichments in the house. As a result, it is imperative that the surviving plasterwork be stabilised in a more permanent fashion to preserve the architectural and decorative heritage within No.18 Lady Lane.
